ENGINEERING TEST REPORT

ETR - 924

TITLE: Test Results of the RAH-66 Main Rotor Ballistically Damaged Flexbeam
DATE: 4 August 1997
A/C SERIES: RAH-66
A/C MODEL: RAH-66 Prototype
SYSTEM: Main Rotor
CHARGE NO: CB571-300
CONTRACT NO: DAAJ02-97-M-0001

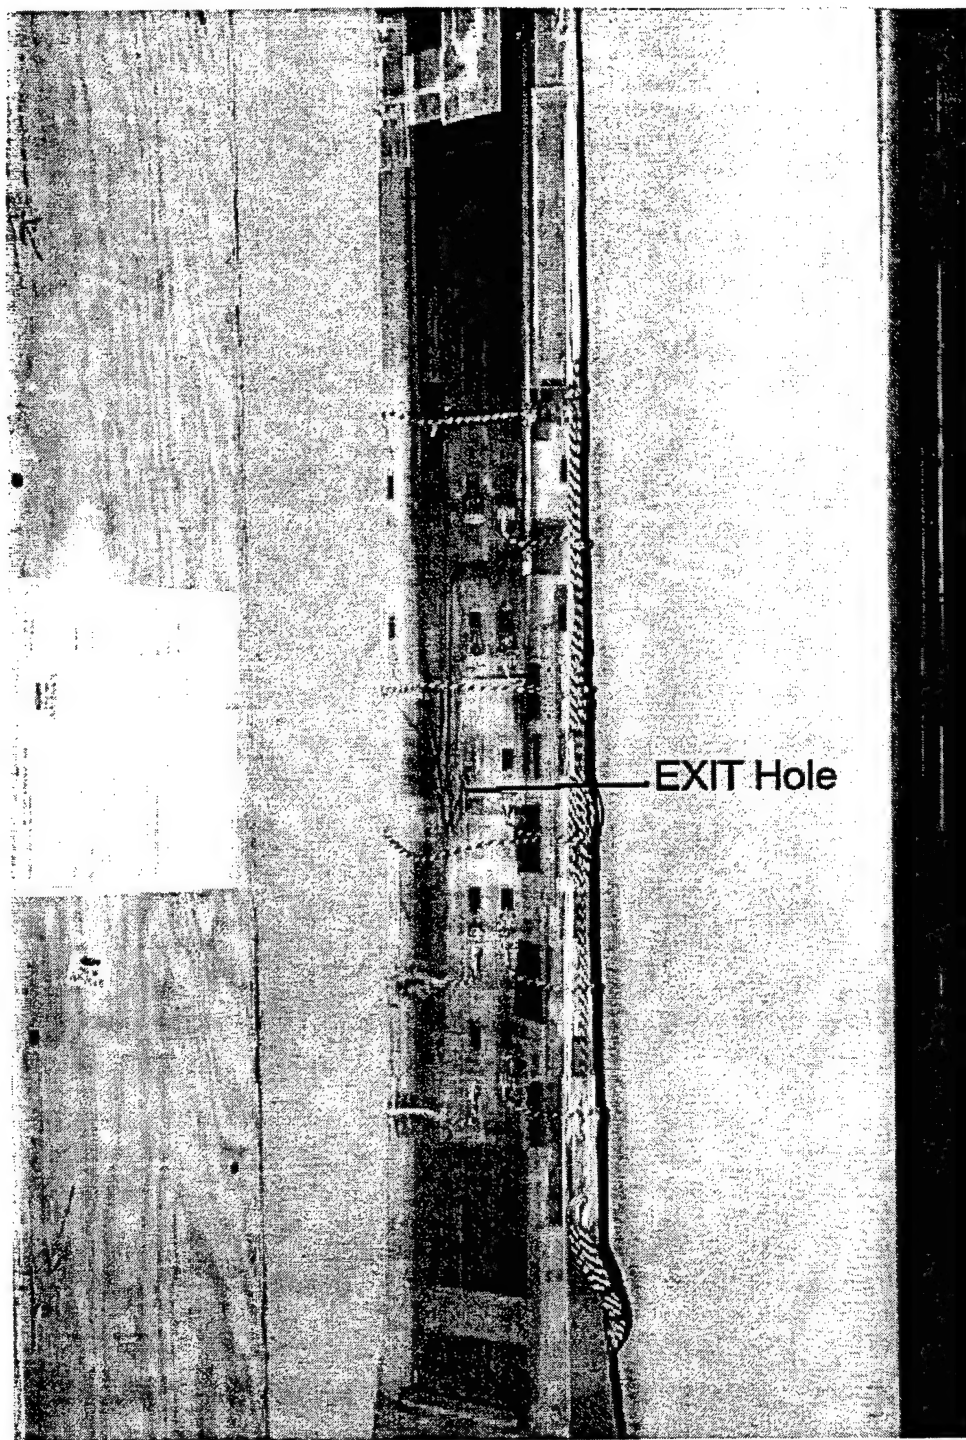
Figure 5 Ballistically Damaged Flexbeam Topside View

The ballistic damage of the S/N 0044 flexbeam is located at the inboard transition area. The projectile entered the flexbeam lower surface and exited through the upper surface approximately 13 inches from the root end, Ref. Figures 5 & 6. There was a heaping of delaminated and broken plys 1 inch tall, tapering down to 0.100" high, Ref. Figure 6. A crack extends from the center of the impact hole inboard 13" and outboard 17 1/2", Ref. Figures 8, 9 & 12.

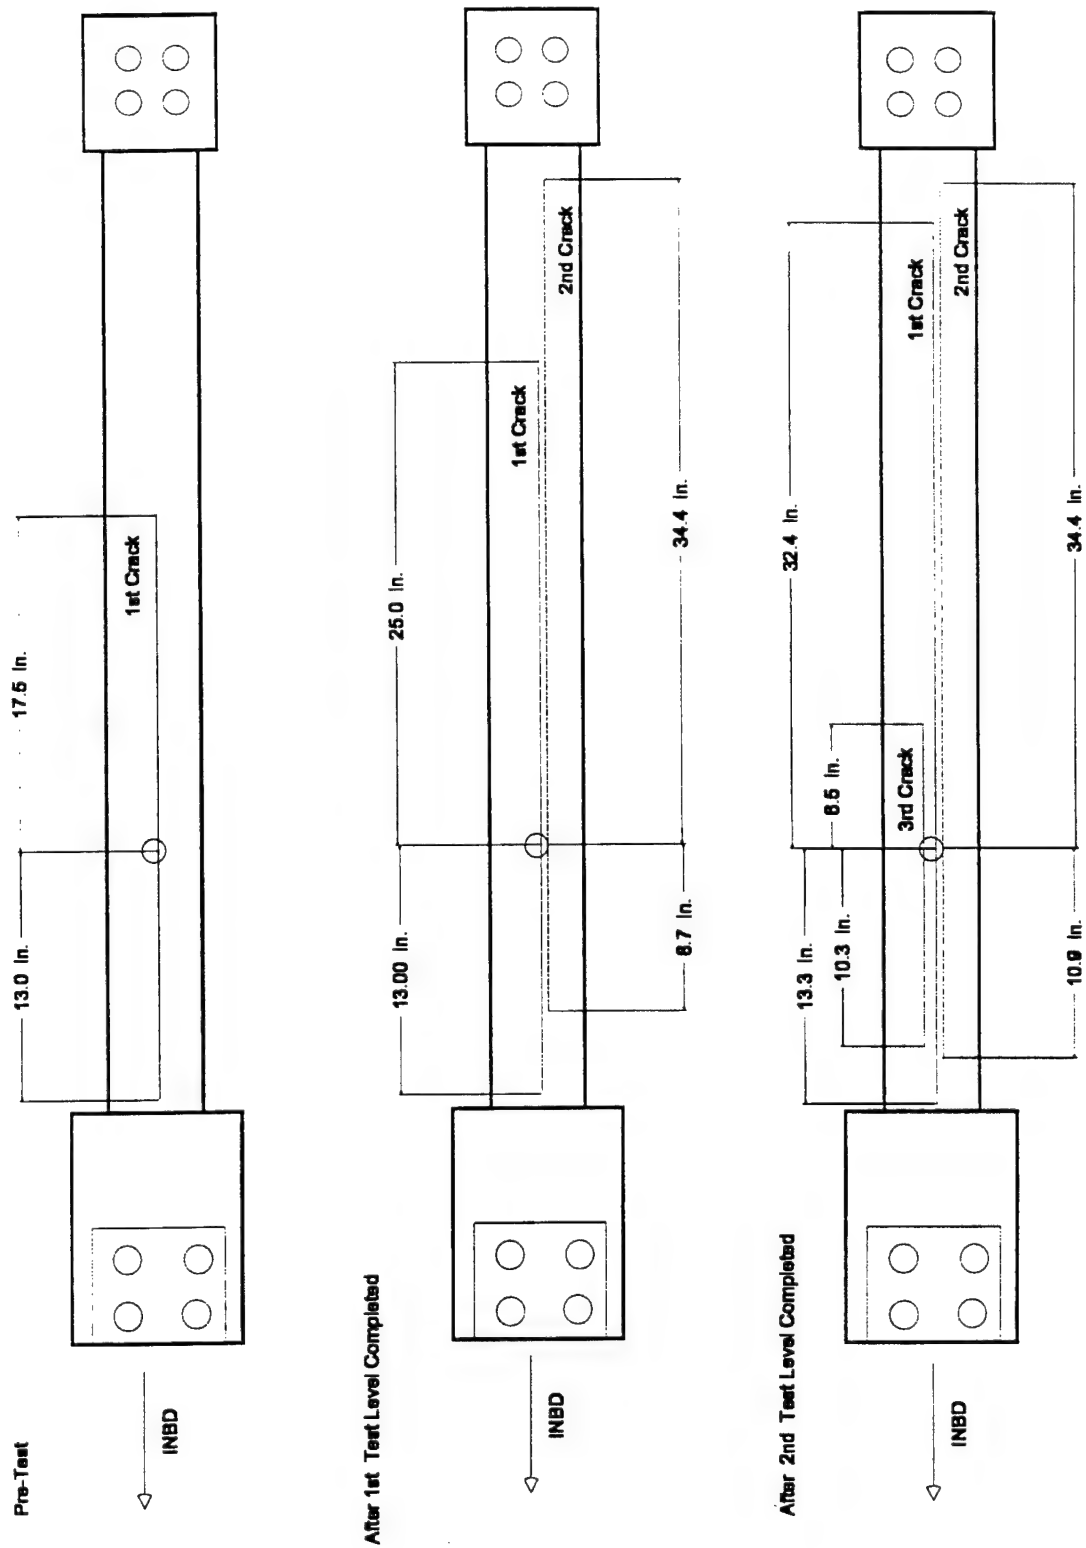
Figure 12 Flexbeam Crack Propagation Sketch

Refer to Figure 12 for discussion below.

During the first test level, the crack propagated 7.5" outboard to a total length of 38". A second crack parallel to the first started and propagated 8.7" inboard and 34.4" outboard to a total length of 43.1"

During the second test level, the first crack propagated an additional 7.4" outboard and 0.3" inboard to a total length of 45.7". The second crack grew an additional 2.2" inboard to a total length of 45.3". A third crack started and propagated to 10.3" inboard and 6.5" outboard to a total length of 16.8".

A test or analysis to assess the change of dynamic response, and its stability impact, of the flexbeam due to ballistic damage and crack growth is recommended.
